1. Status of HXN IVU Repair
2. Planning future operations at 500 mA

UEC Town Hall Meeting  
December 11, 2018

# HXN (C3)-IVU Incident

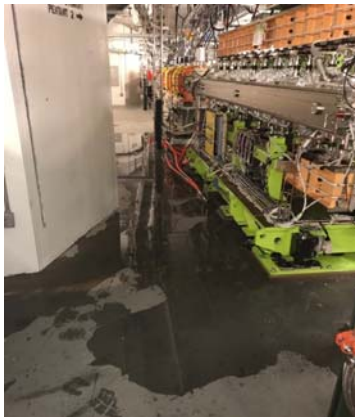
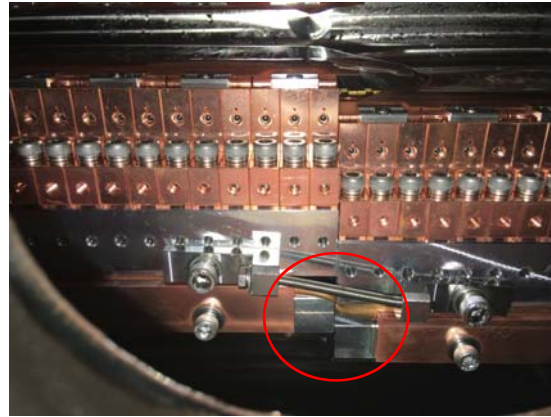
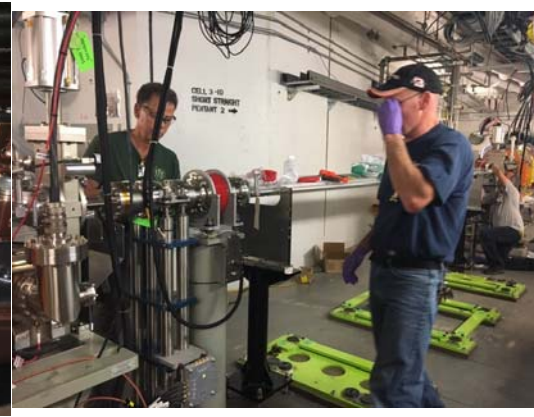
- Just after midnight (0:08) on 7/1/2018, C3-IVU gap stopped responding. Soon after (0:11) gate valves around the straight closed. Operator stopped water at 2:23am.
- With truly commendable effort by all the AD groups, the device was uninstalled and the straight was back to operation with only 30 hours of loss of operation.
- The device was transported to ID-MMF (bldg. 832) for repair.
- This was the first accident of this nature by this manufacturer with more than 30 IVUs of similar design.

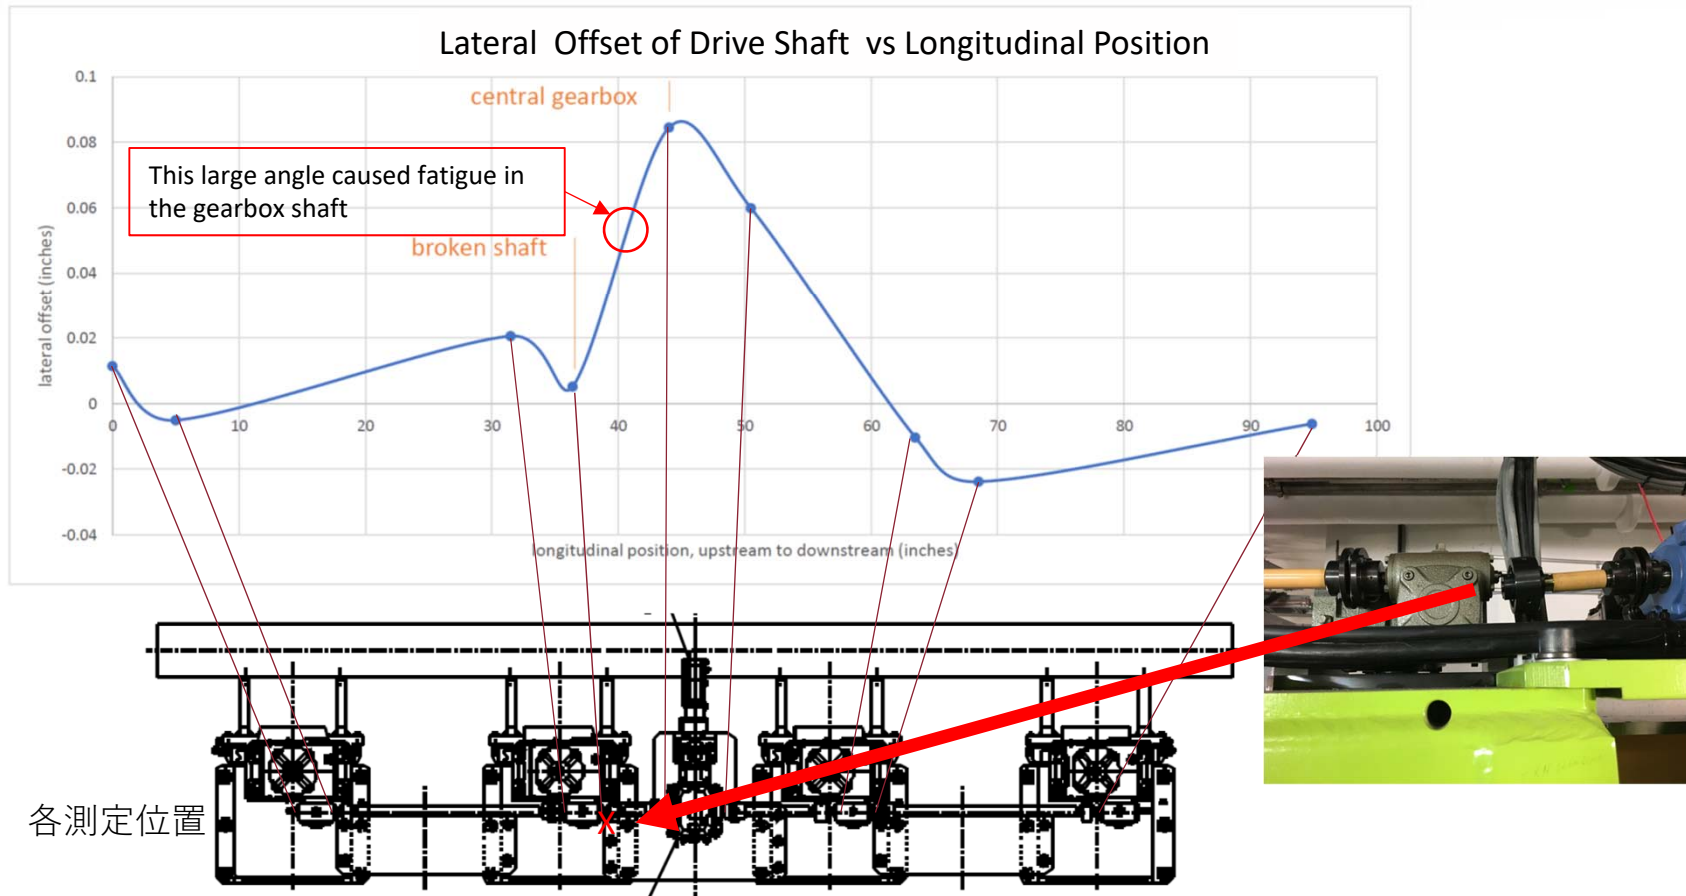
# Root cause

It was determined that the primary root cause of the gearbox shaft failure at Cell 3 is misalignment of the drivetrain. It was likely to be created during transportation.

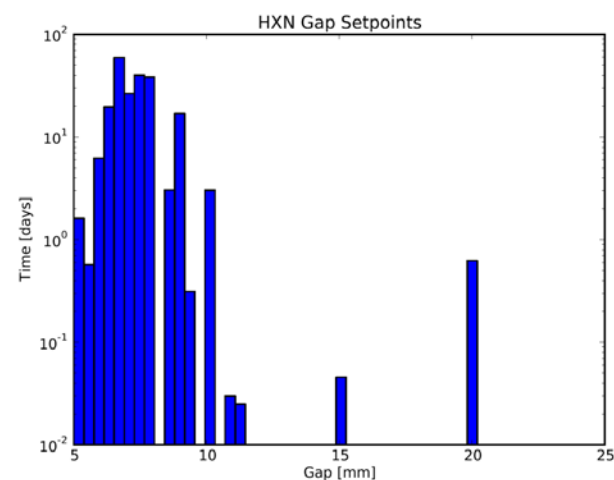
PE optimized for most used gap range
