# Machine Update

## **NSLS Town Meeting**

**Friday, August 12, 2011**

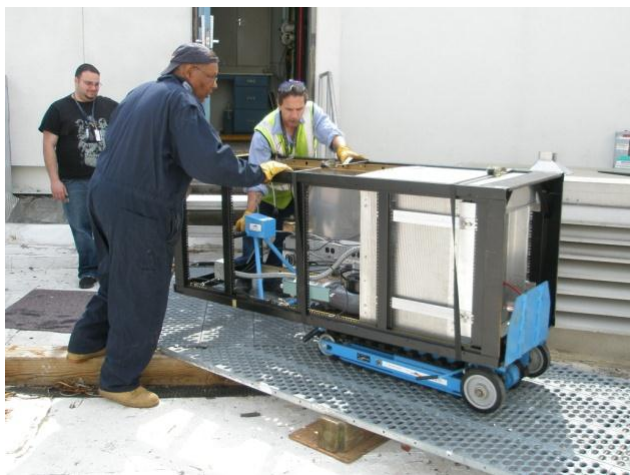
Cooling lines are added

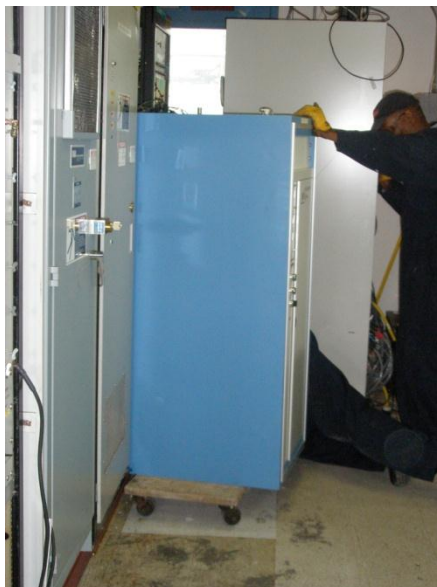
New amplifier slides into place

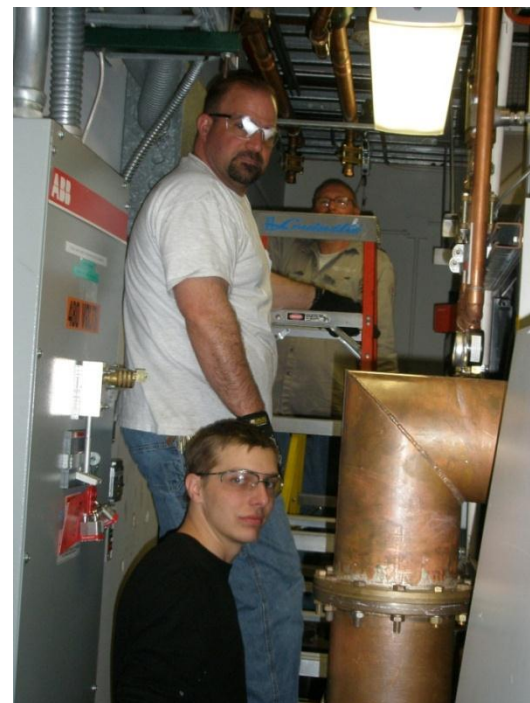
Riggers remove the tube rack

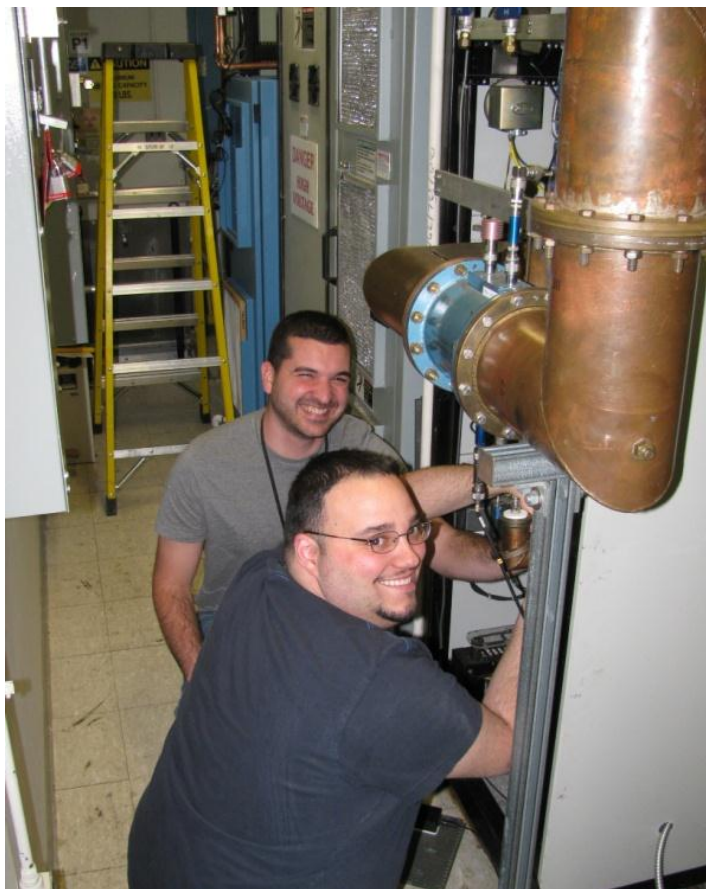
Completing the RF connections to the 123kW amp

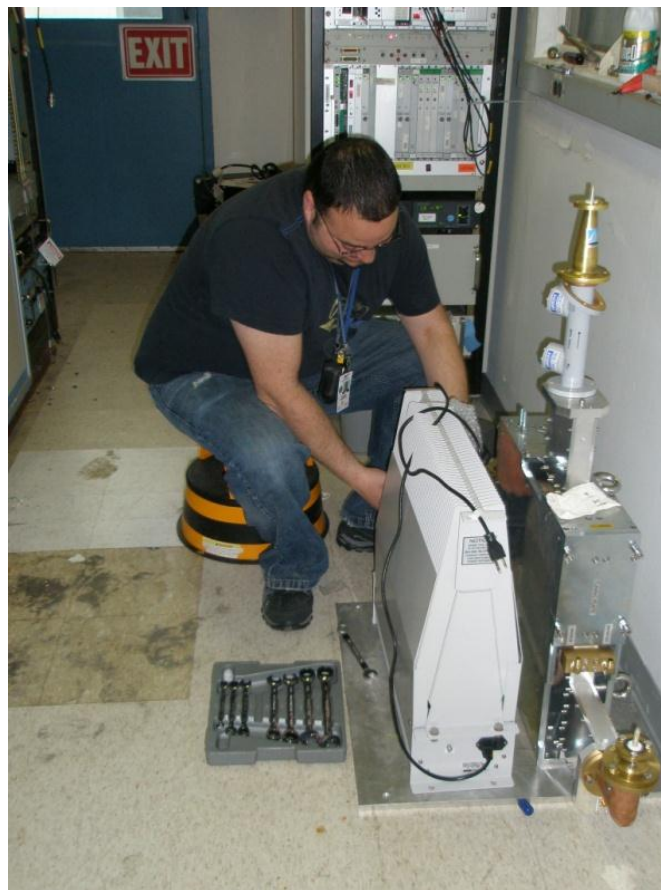
Preparing the circulator

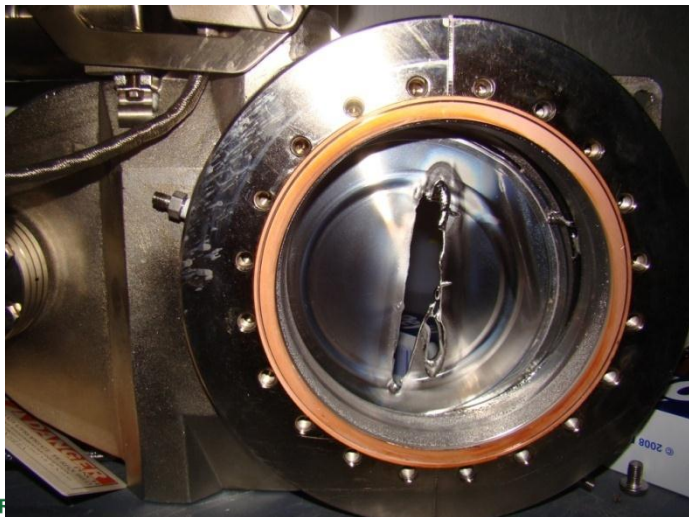
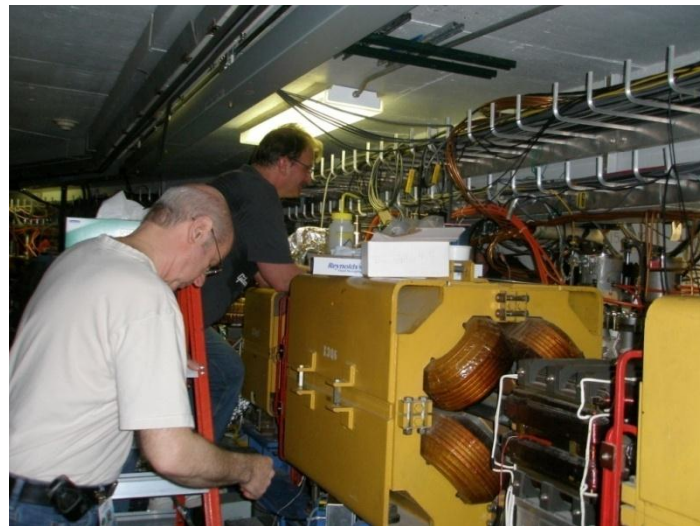
# X16 GP Vacuum Valve Replacement

- Two failures permitted exposure of the GP valve to x-rays.
- Caused significant damage to the valve.
- Equipment protection system was checked at X16 and the rest of the ring following this incident to look for other latent errors.
- Replacement required the bleed-up of SP3 to replace the valve.
- Periodic testing of all equipment protection systems will be done during maintenance and shutdown periods to identify and fix interlock problems.

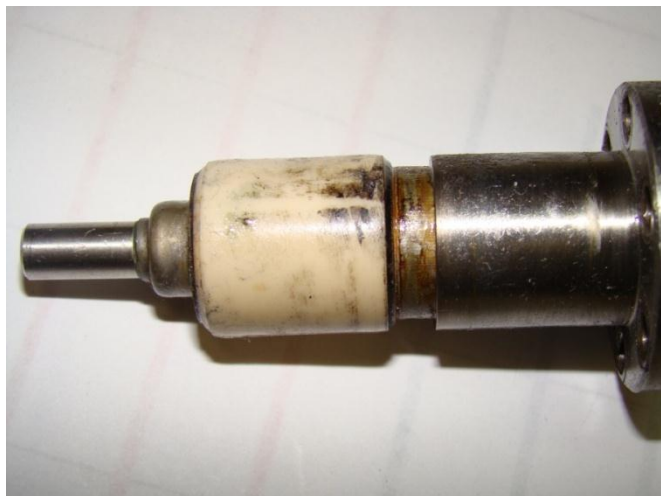
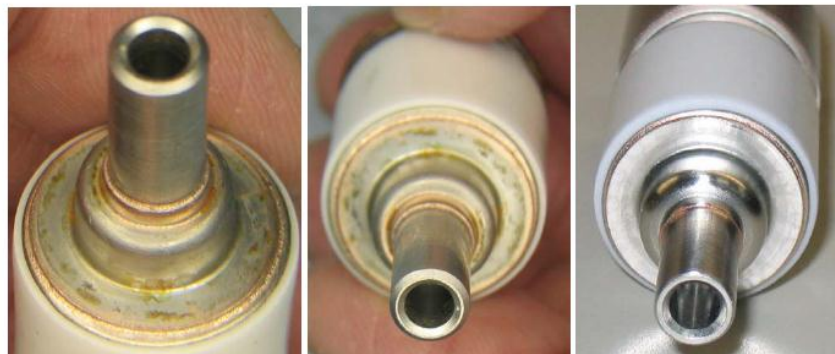
# X8M3 High Voltage Vacuum Feed-through

- Leak in the high voltage feed-through caused vacuum issues in SP1/8 several times.
- Spray sealant applied each time, but it was only a temporary fix.
- Active corrosion discovered on the braze joint.
- This is a known problem for which Gamma Vacuum has a solution.
- Discussing plans to inspect others at the start of shutdown periods.
- Many have become inaccessible.
- We will maintain an adequate spare stock to see us through to the end of operations.

Corrosion Testing at Gamma Vacuum

Results are Following Weekend Salt Test

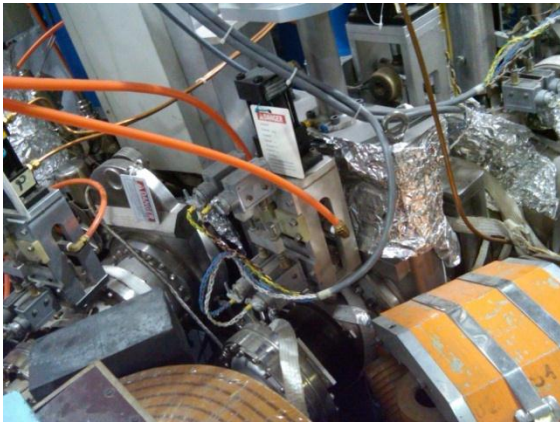
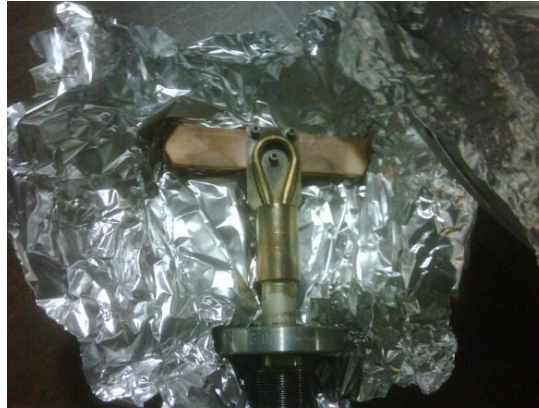
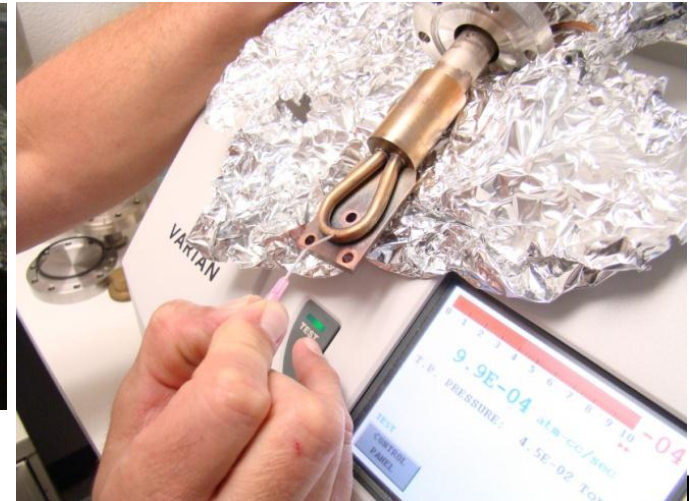
# U6 Water-Cooled Mask Vacuum Leak

- VUV developed a vacuum leak in the water line of the U6 water-cooled mask.
- Failure may be related to bend stress coupled with age and constant exposure to light (U6 is unused and mask stayed closed).
- Mask was replaced with a water-cooled cap.
- Recovery was slow due to the water contamination.
- We still have not returned to pre-failure conditions, but we're close.
- We have spare masks on hand and this one has been rebuilt and is a spare.
