Machine Update

NSLS-II Town Meeting

Wednesday August 5, 2015

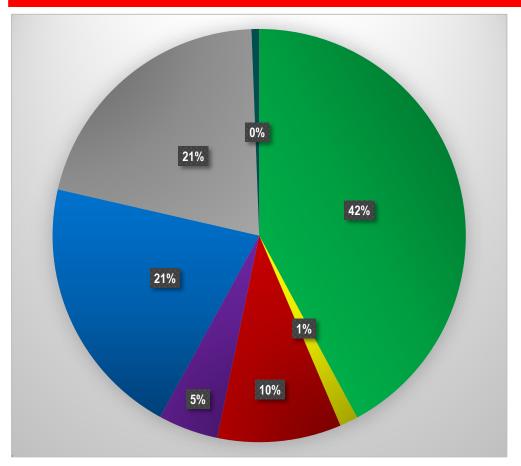
Statistics Through July31st

Operations: 1740.4 hrs
Injection/Setup: 59.1 hrs
Sched. Studies: 851.7 hrs
Sched. Maintenance: 194.2 hrs
Failure: 400.3 hrs
Shutdown: 859.6 hrs
Unscheduled Operations: 24.7 hrs

Reliability:

Of 2074.4 scheduled hrs from Feb-July 2015:

Operations: 83.9%

Injection/Setup: 2.8%

Failure: 13.3%

Availability:

Delivered Beam Time: 85.1%

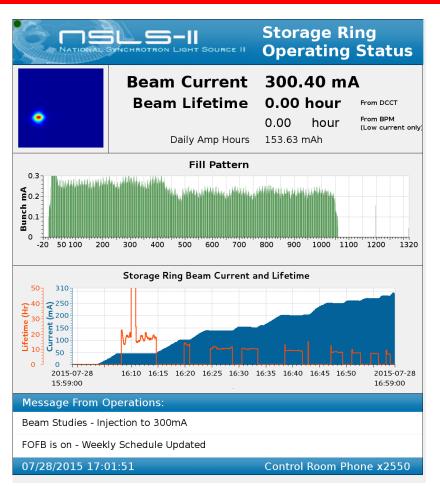
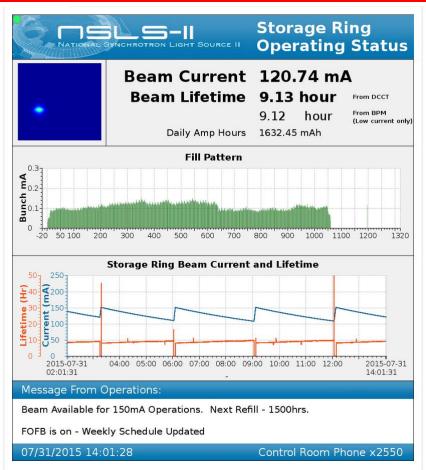
Storage Ring Performance

300 mA!

Routine Ops at 150 mA

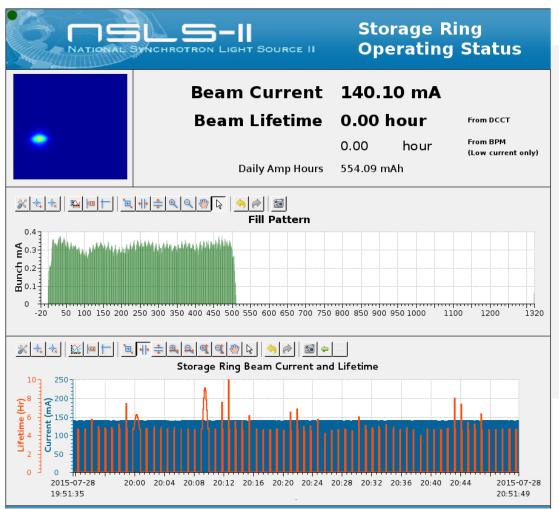
Results from Top-Off Injection Studies on July 28th

Preparation for Top-Off operation continues at a good pace.

- ✓ 20% bunch-to-bunch variation has been achieved (ignoring the leading and trailing bunches)
- ✓ 0.5% variation in ring current has also been achieved.

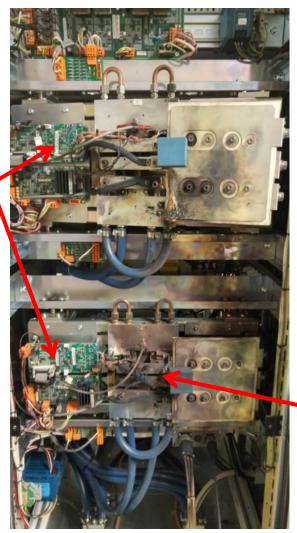
Damaged IGBTs and Their Driver Cards in the BD1 Power Supply

Driver Cards

IGBT stands for Insulated Gate Bipolar Transistor

IGBTs Mounted Behind Cooling Plate

- At 1:31 am on July 12th the Operator on-duty received an alarm that the BD1 power supply had tripped off.
- The booster dipoles are fed in 2 strings with 2 separate but identical power supplies, BD1 and BD2.
- The power supply ratings are 750 A and 700 V which is required to drive the magnets to full field @ 3GeV in only 300 ms. The supplies were manufactured by Danfysik
- After attempts to reset the supply via the control system an operator and floor coordinator inspected the supply and found that both the DC output breaker and the AC line breaker had opened.
- Calls went out to technical experts.
- Upon their arrival on Sunday morning, they found that the supply had extensive damage from internal arcing.
- This was obviously going to require some time to complete the repair.

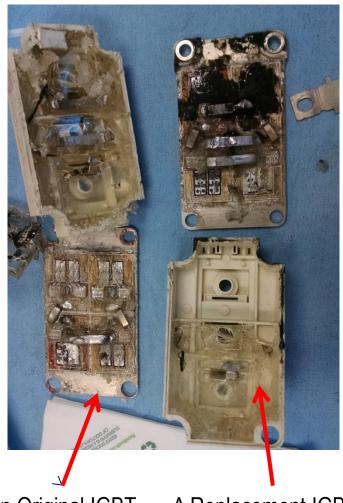
BD1 IGBT Failures

An Original IGBT

A Replacement IGBT

- The root cause is believed to be a damaged high voltage cable in the power supply.
- Repairs were completed late on Monday. After careful inspection and testing in an inactive state the power supply was re-energized.
- At this point the supply failed again in the same manner.
- Following additional failures we obtained an AC transformer that allowed us to perform tests at current-limited, intermediate voltages giving us insight and control of the method of failure.
- We were also fortunate to redirect the Danfysik engineer who designed and built the power supply from his vacation in Canada.
- It was discovered that the specifications for our spare IGBTs differed from the original IGBTs but had the same part number. The gate drive resistance needed to be 4 ohms for the spare components instead of 2 ohms required and built into the supply for the original components.

- Following complete replacement of all IGBTs with an upgraded part, the power supply was able to be returned to full service on July 24th at 3:05 pm.
- Our thanks go out to everyone involved with the repair for the long and frustrating hours spent chasing this problem.
- Despite the high power that they were working with, all activities were conducted with safety having the utmost importance.
